Mont Blanc Remote Control Issue

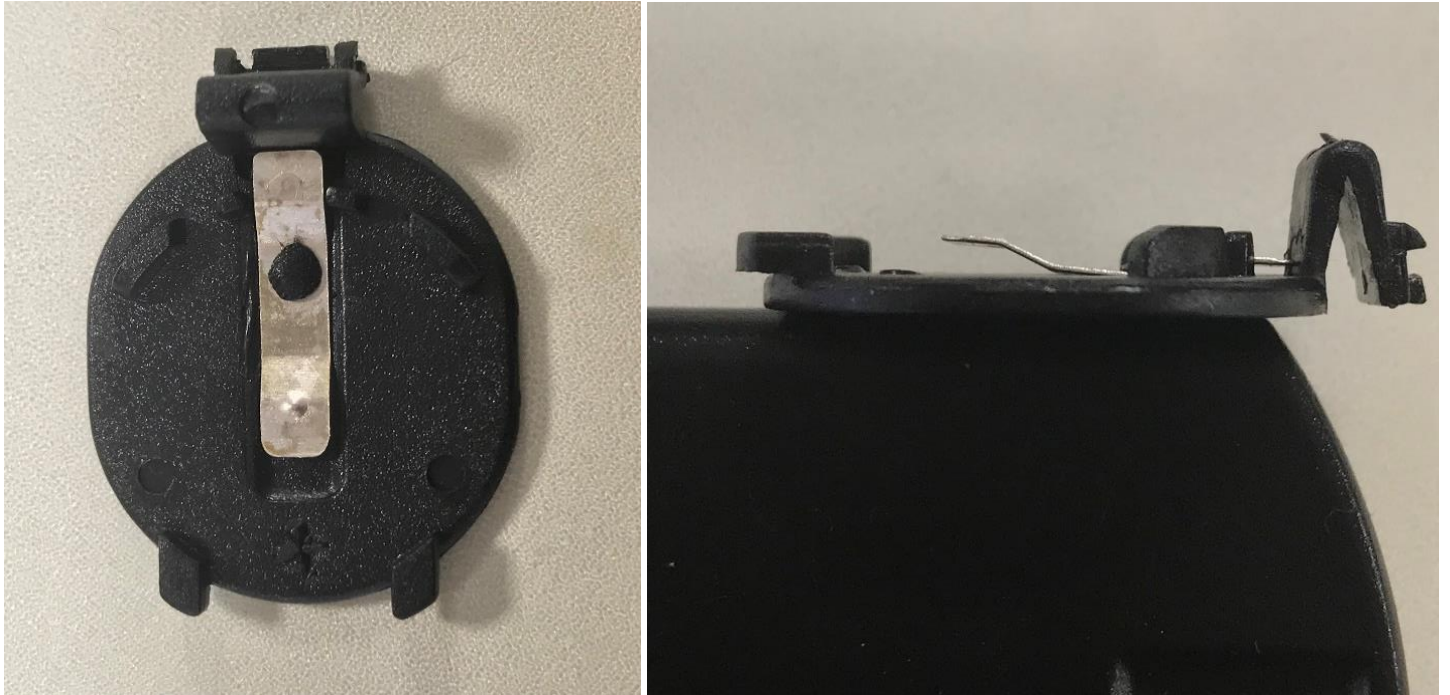
Following an increasing number of reports of faulty Remote Controls used to operate the Mont Blanc Fan, a number were returned for inspection/testing. As a result it was discovered that the metal contact tab on the reverse side of the lid to the battery housing was not making contact with the battery surface as it is required to do. This issue can be easily resolved by the customer. Simply place a finger under the lip of the tab and gently lift until it is sat 'proud' of the lid. This will ensure that the tab will make contact with the battery when the lid is located.
